To: Primary School

Property address: Corner of Maths Street and History Lane, Preston.
Victoria.

Date of inspection: 12 September 2014

The purpose of this report is used to identify the cause of water ingress through various areas of the new building and also the front entrance area.

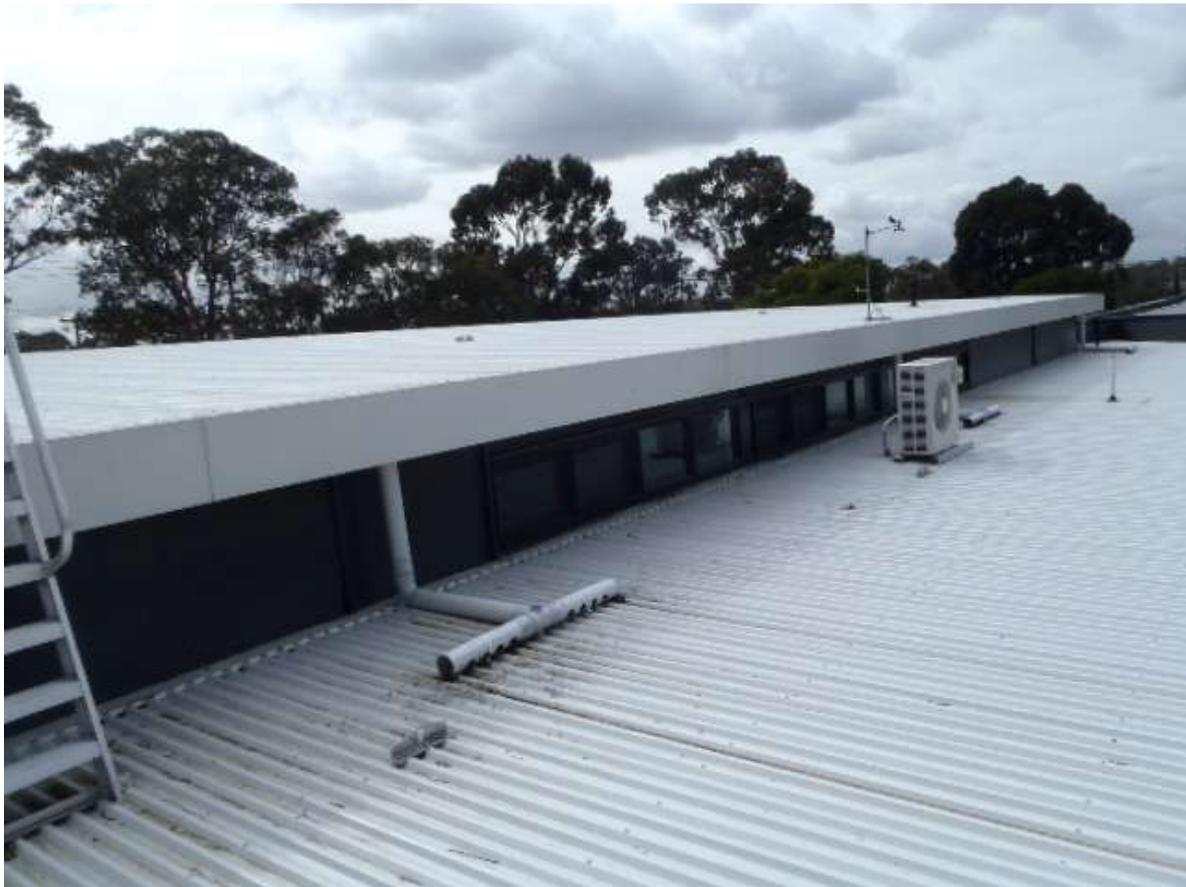
There are and upper and a lower sections of roof (See below).

The box gutter at the rear of the upper section discharges onto the lower roof via spreader pipes (See photo above and on next page).

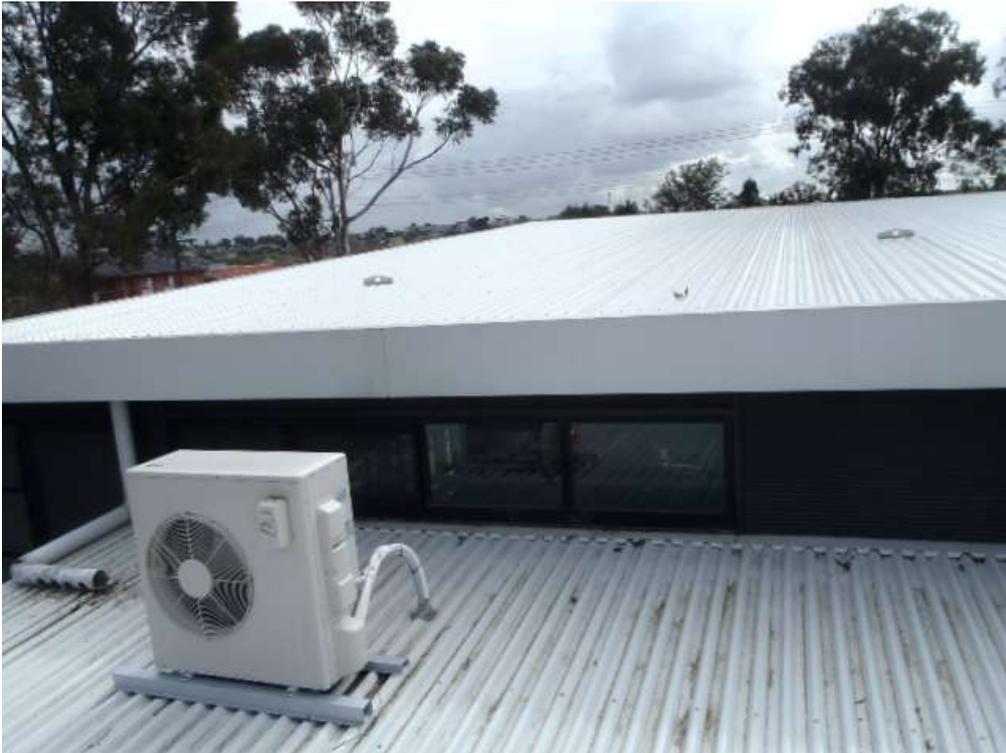
In the past and according to the caretaker these spreader pipes have become blocked causing water to backup in the upper box gutter. There are overflow outlets cut into the sole of the box gutter which discharge through the eaves lining (See below).

The first three spreader pipes from the left (Viewed from the rear of the building) are not compliant because they discharge water from a roof area larger than 15m² onto a lower roof ('Installation Code for Metal Roofing and Wall Cladding SAA HB 39-1997' Page 53).

- Extend the downpipes all the way down the roof to discharge directly into the lower gutter via a 90° bend facing towards the nearest downpipe outlet.

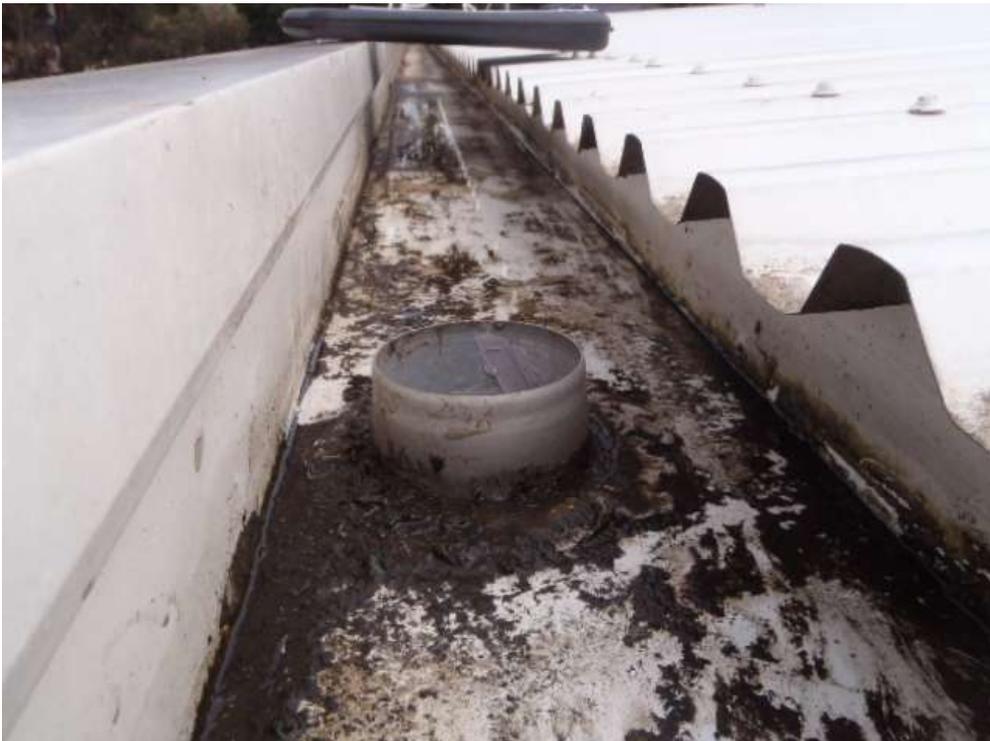
There are however only two 90mm diameter overflow outlets in a box gutter that has for 100mm diameter downpipe outlets.

According to the 'Installation Code for Metal Roofing and Wall Cladding SAA HB 39-1997' (Page 37) issued by the Victorian building authority, overflow outlets must be equal to or greater in size than the cross-sectional area of the downpipes. These overflow outlets will work well in most situations because it is unlikely that all of the downpipes will become blocked with leaves and mud at the same time. However in the case of heavy hail turning to ice in the box gutter all of the downpipes would be blocked at the same time and the overflow outlets would need to take over which currently they would not be able to do.

The overflow outlets discharge water directly down onto the apron flashing of the lower roof as opposed to discharging compliantly clear of the building ('Installation Code for Metal Roofing and Wall Cladding SAA HB 39-1997' Page 37). This would be difficult to achieve however in my opinion downpipes could be connected to the overflow outlets in order to discharge the water further down the roof away from the flashings.

- Install enough extra overflow outlets in the upper box gutter to be at least equal to the cross-sectional area of the downpipe outlets.
There are also insufficient overflow outlets in the lower gutters.

- Install downpipes with spreaders to the underside of the overflow outlets in order to discharge the overflowing water down the roof and away from the apron flashings.

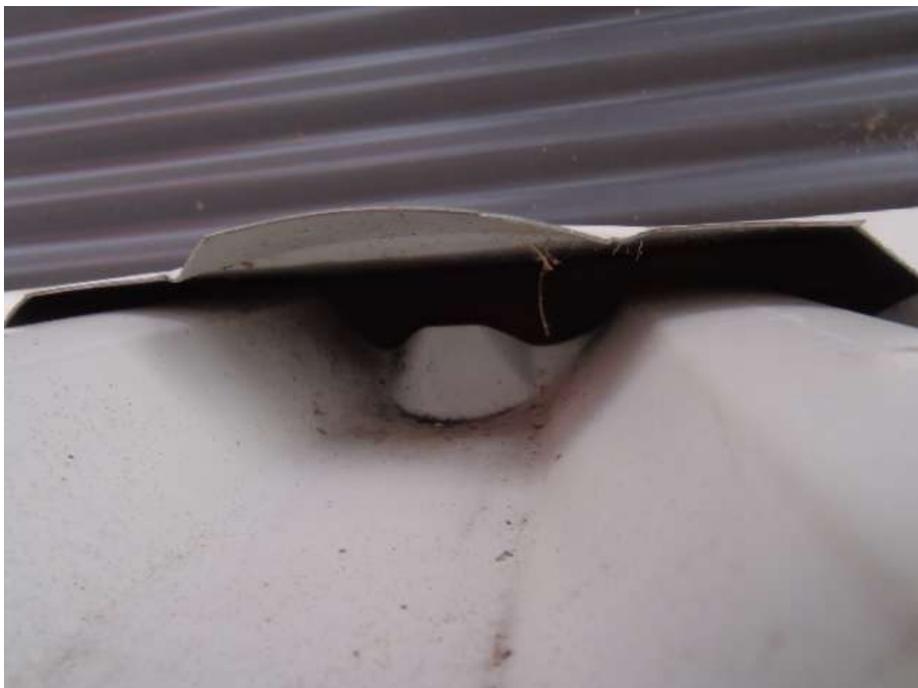
On inspection of the top end of the lower roof I found that the roof sheets are short meaning that the apron flashing only provides approximately 60 mm of cover over the weathered ends of the sheets (See below).

The minimum compliant cover for a transverse apron flashing is 150mm, therefore the flashing does not comply ('Installation Code for Metal Roofing and Wall Cladding SAA HB 39-1997' Page 85).

I believe that this issue has been the main cause of water ingress especially when a spreader pipe has become blocked or the upper gutter is inundated causing water to flow out of the overflow outlets directly onto the undersized flashing. Driving rain would also be a contributing factor.

- Install a new apron flashing between the lower roof and the wall of the upper level. Make sure that the minimum 150mm of cover is achieved. 200mm of cover would be preferred.
It might be a good idea to install corrugated foam infill strip between the underside of the apron flashing and the top end of the roof sheets.

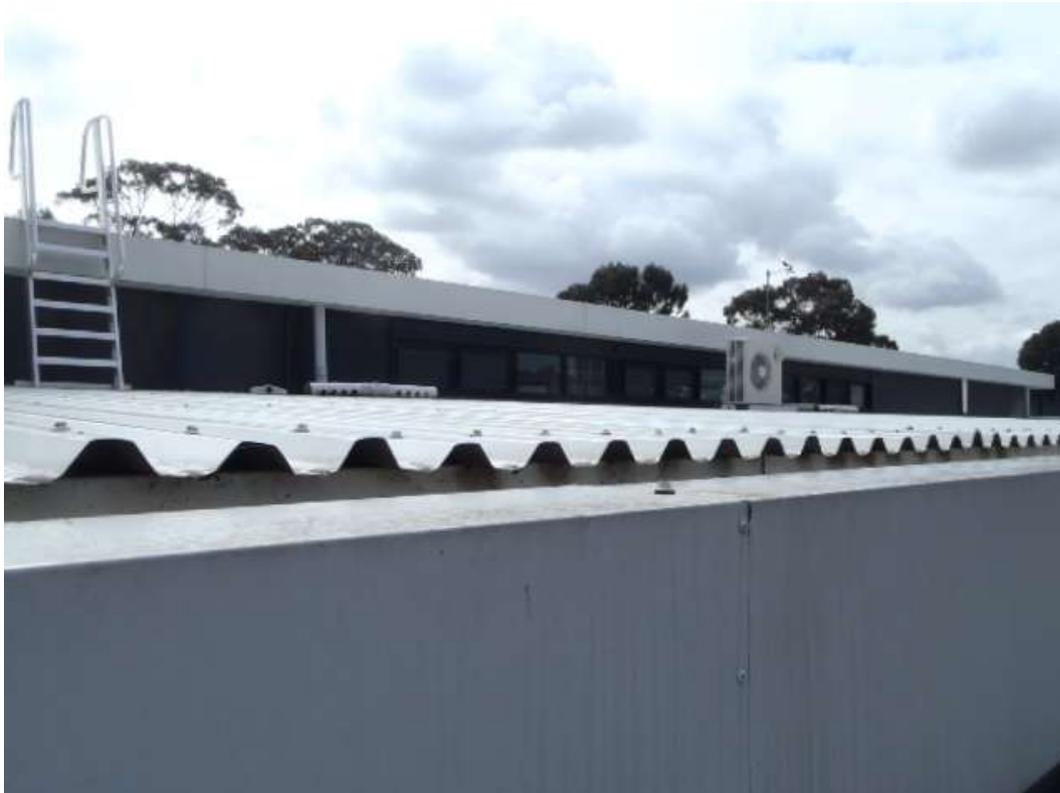
The parapet at the front of the lower box gutter is much lower than it is for the upper gutter and the roof ends are very exposed to driving rain (See below).

- To protect the open ends of the lower roof sheets and baffle flashing could be installed on the inside of the parapet wall extending up about 200mm.
Alternatively a 200mm x 100mm angle flashing could be installed across the tops of the roof sheets overhanging the gutter. Make sure not to block off the flow of water from the roof sheets.

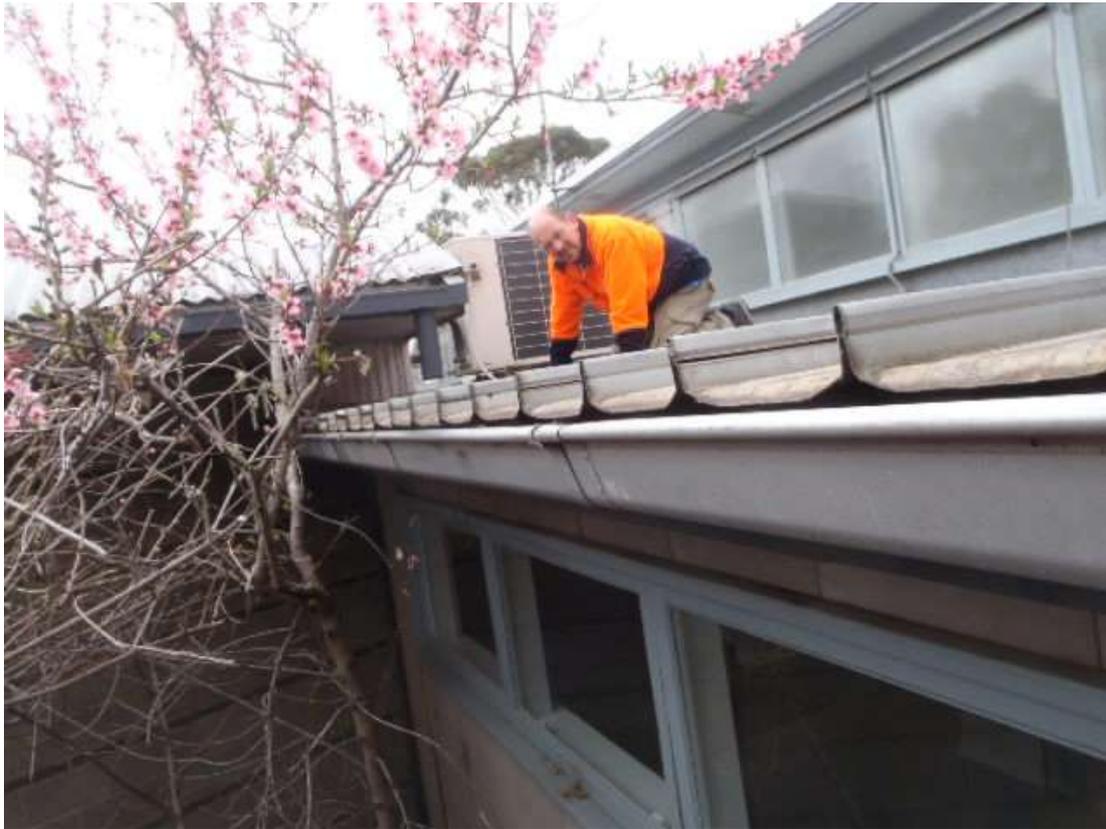
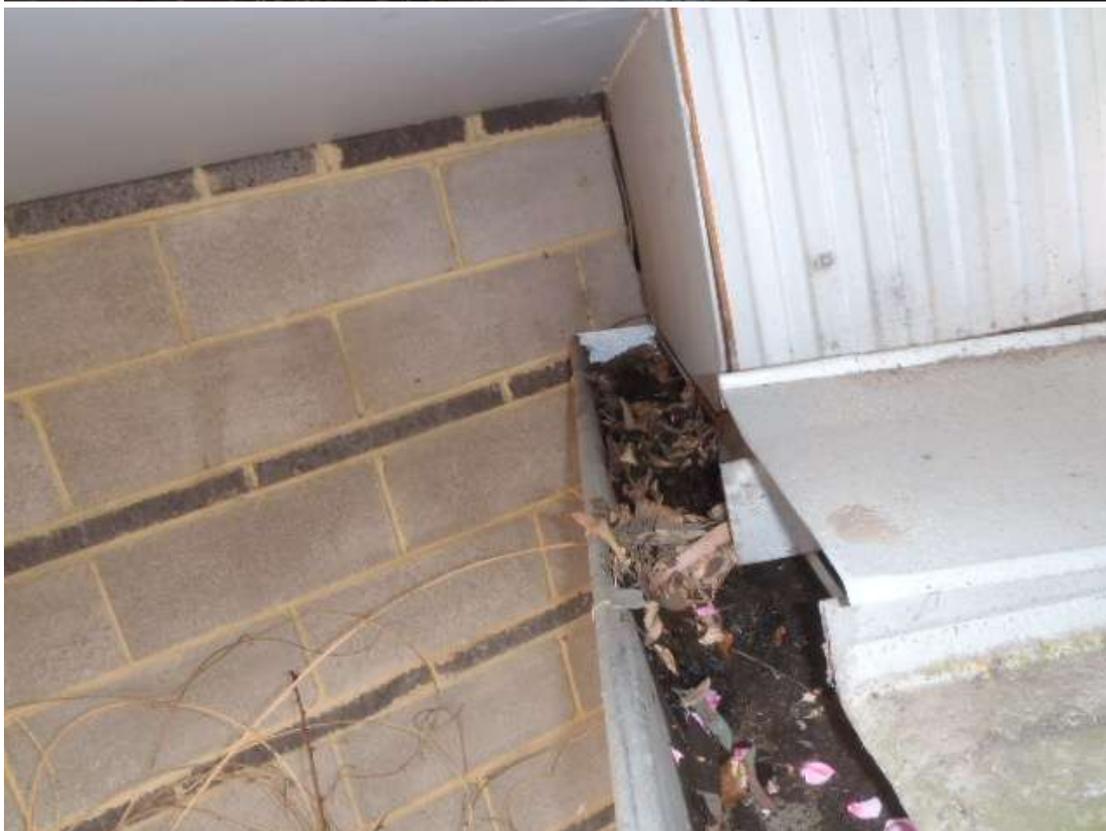
Area 'A'

At area 'A' the gutter running across the front entrance is too small for the water that it now has to carry. The outlets at the end of the gutter have also become blocked with mud and leaves etc causing the gutter to overflow back into the soffit lining (See photos on next page).

It would be a good idea to upsize the gutter to a Lysaght high front 'Sheerline' gutter and to install rain-heads at each end to provide provision for overflow (**Areas B** on the diagram).

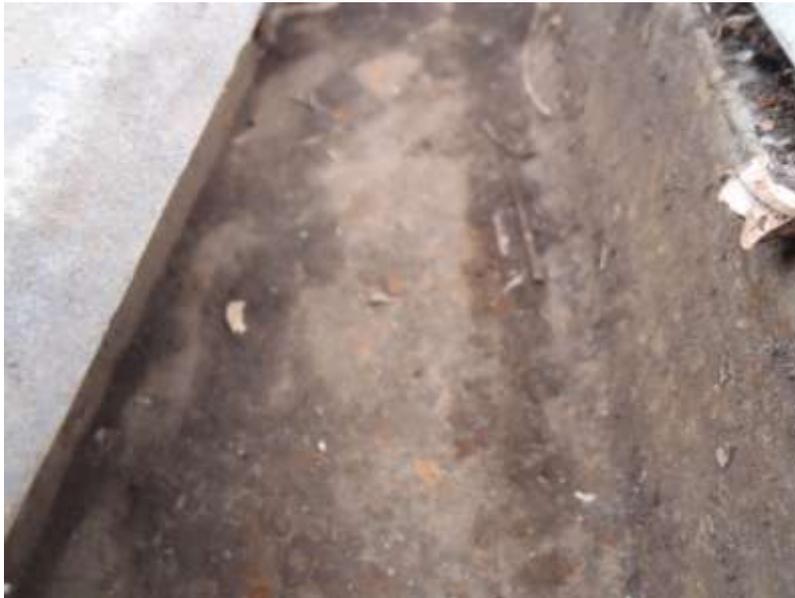
The gutter is also badly surface rusted (See photo below).

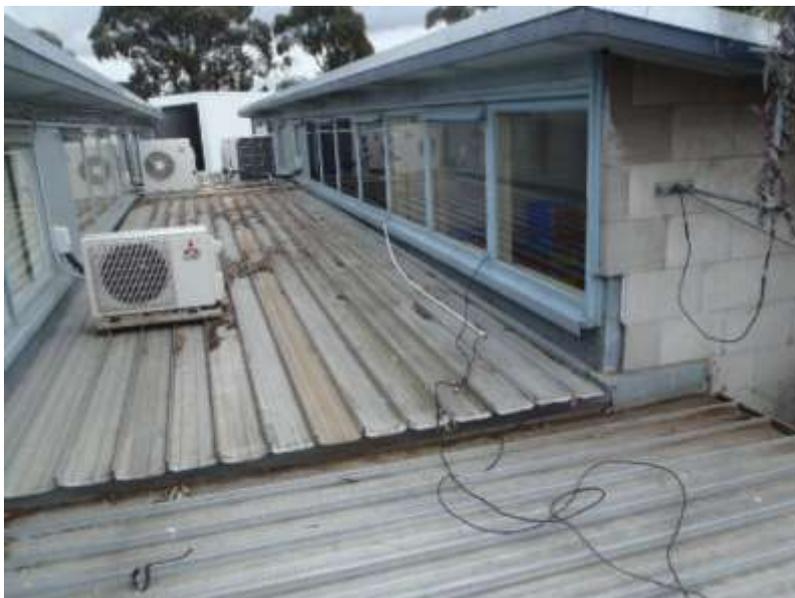
At area C, all the water from the adjacent section of corridor roof discharges into the first roof tray which is likely to become inundated during very heavy rainfall (See photo below).

In my opinion it would be a good idea to install a gutter across the ends of the roof which could discharge the water directly into the new rain-head.

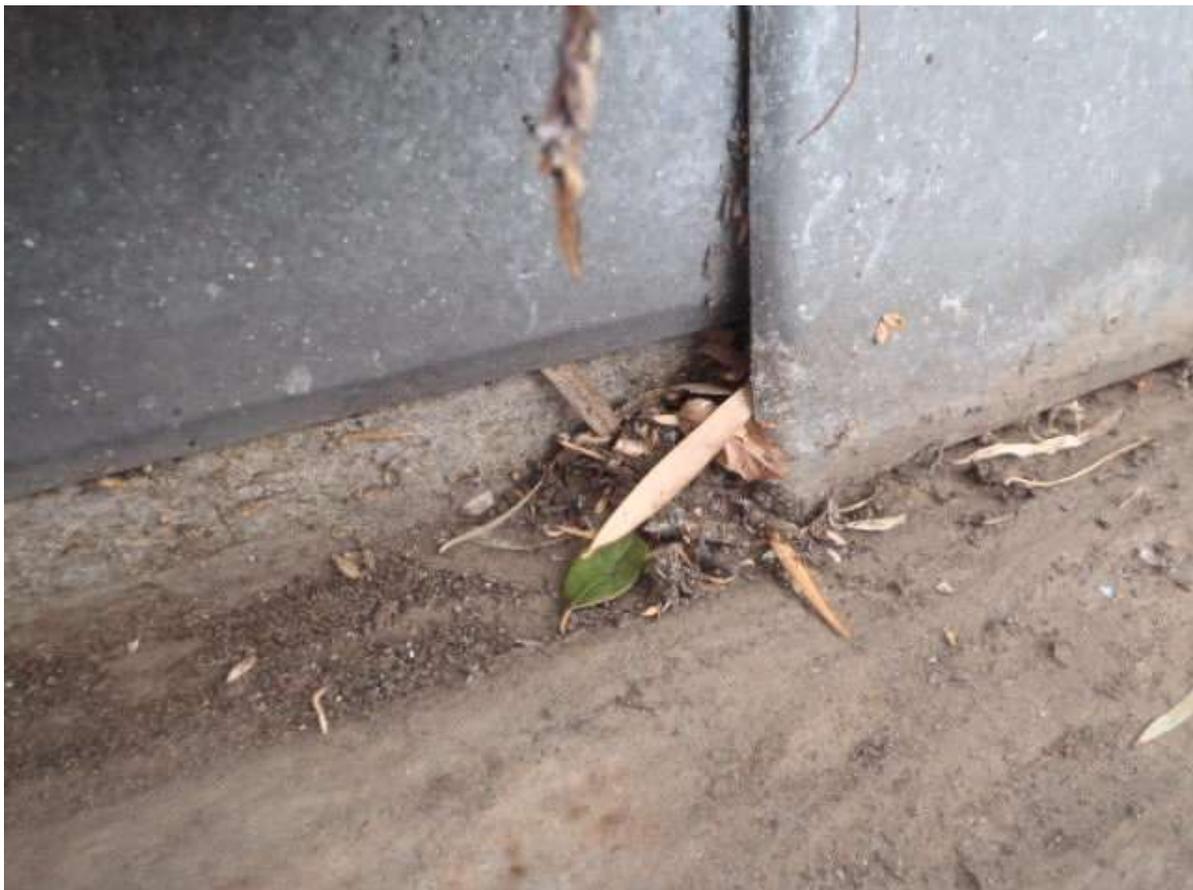
Area D

At area D there is a counter flashing extending right down into the tray of the roof sheet and this has caused debris and mud to build up. This could then cause water ingress especially in its current state due to the volume of water being discharged into this roof tray (See below).

Cut back the counter flashing to the same level as the other flashing in the photo above.

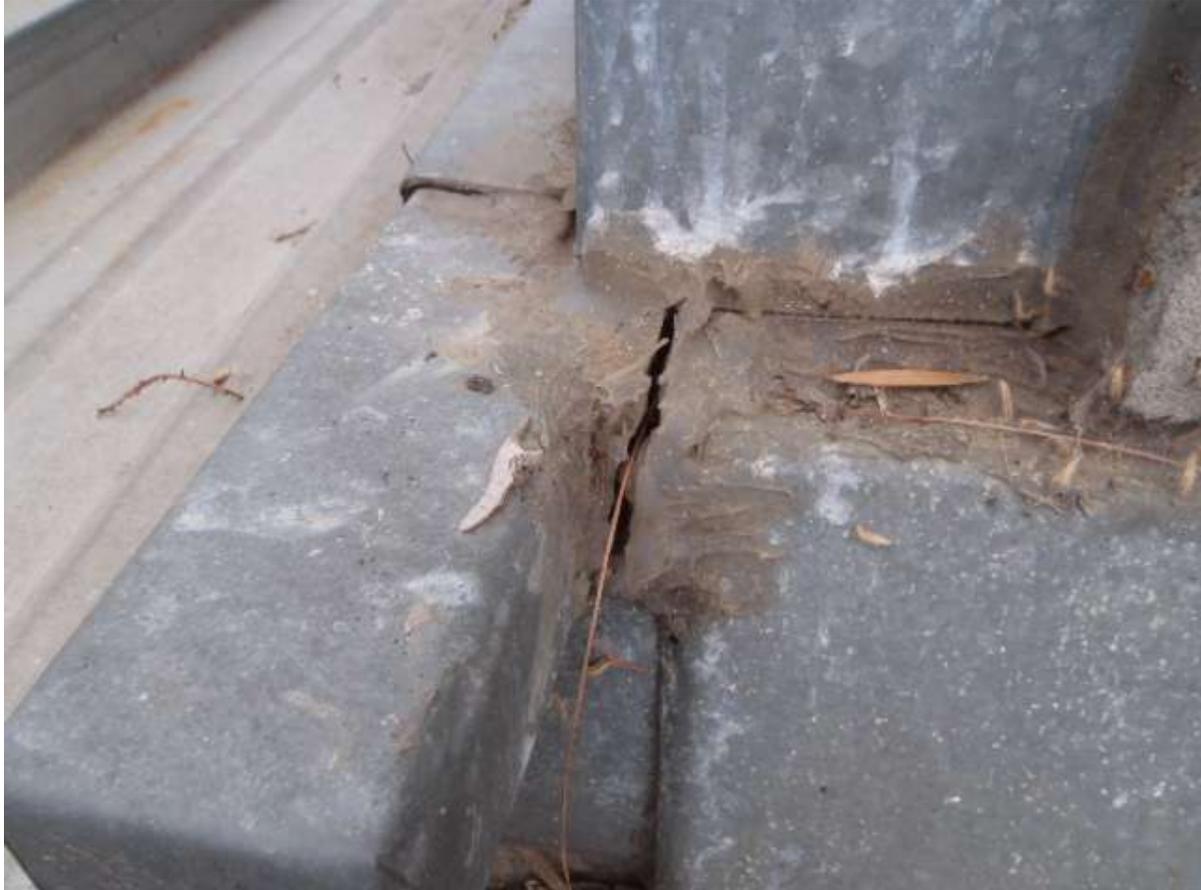
Area E

At area E the join in the flashings has come apart which could allow water ingress (See below).

This area has been sealed previously with silicone but has never been properly repaired.

Clean off all of the silicone and install a new galvanised flashing over the area which is riveted down.

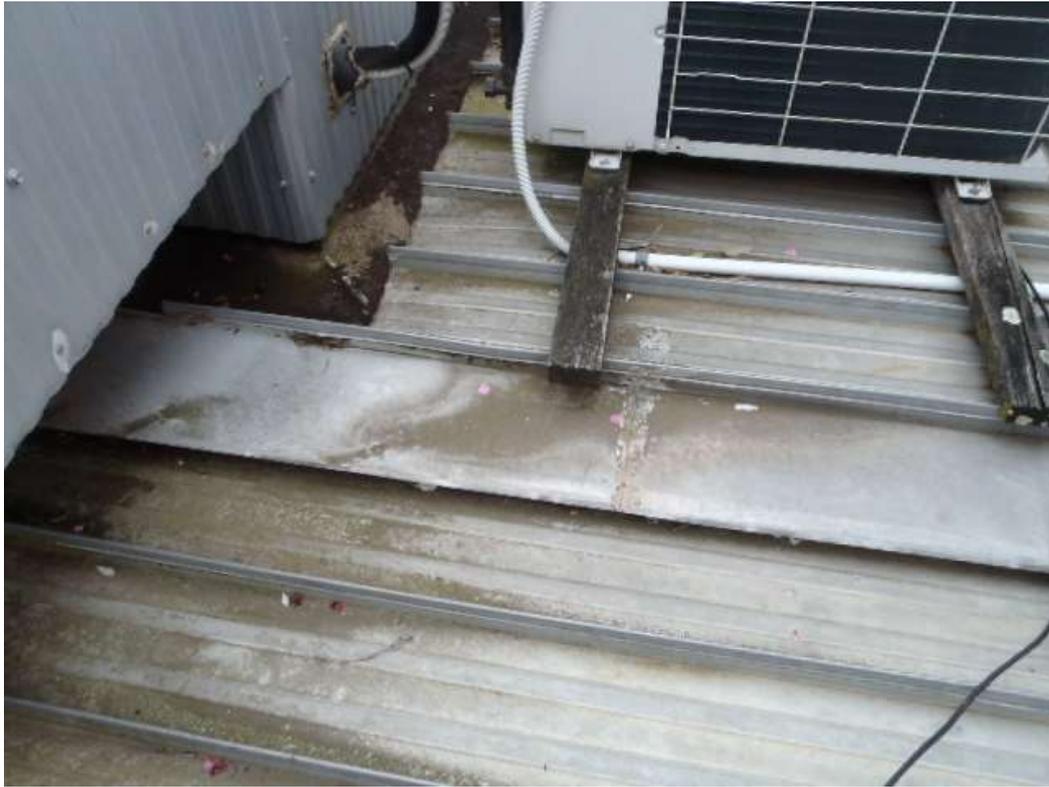
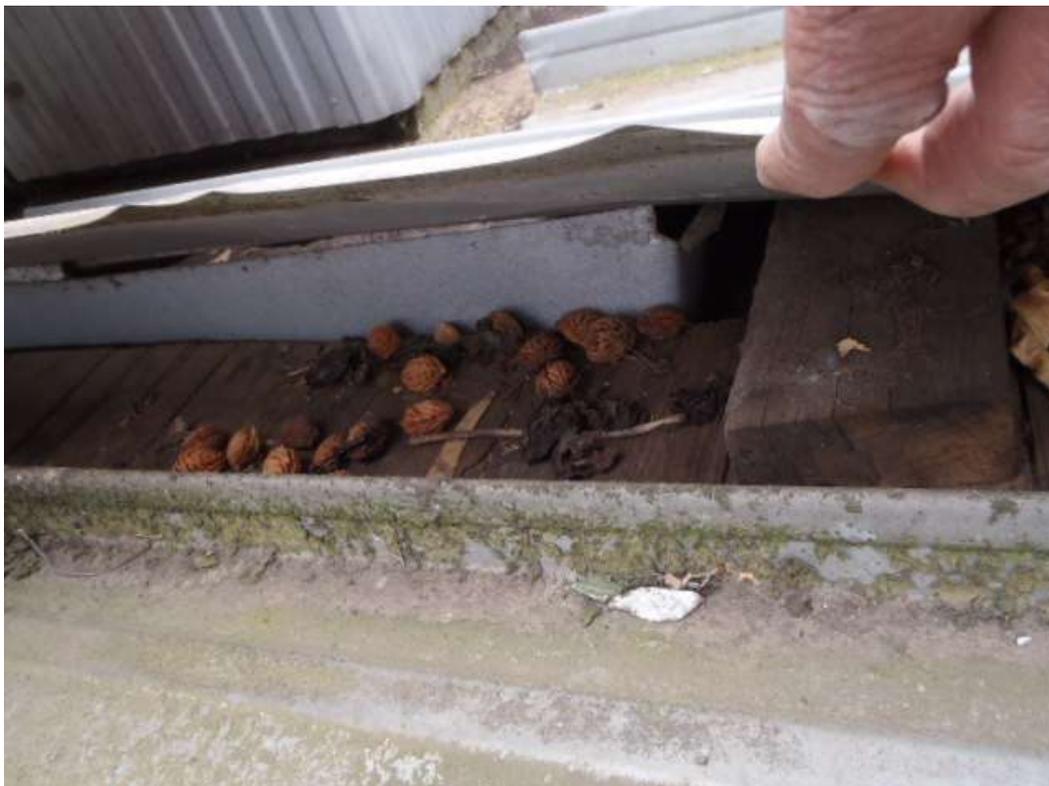
Area F

At area F there is a flashing between the two levels of roof. The flashing is poorly secured and is loose (See photos on next page).

Obviously the local fauna has used this area as a home in the past.
PTO>

Install a hopper flashing that is properly secured across the intersection between the two sections of roof.

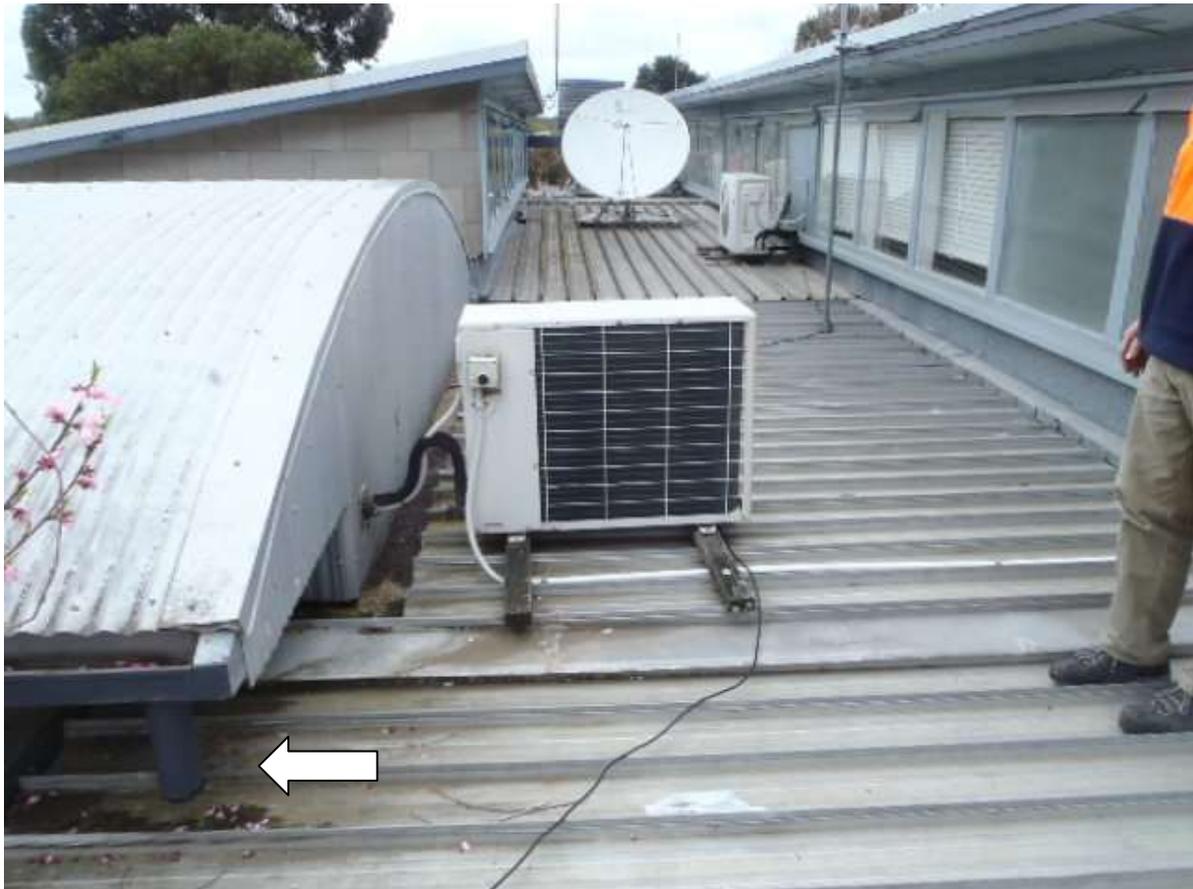
Area G

At area G there is a downpipe from the upper gutter discharging onto the lower roof. There is no downpipe spreader to discharge the water properly (See photo below).

Install a 90mm diameter outlet and PVC downpipe and run the pipe across to discharge directly into the new rain-head.

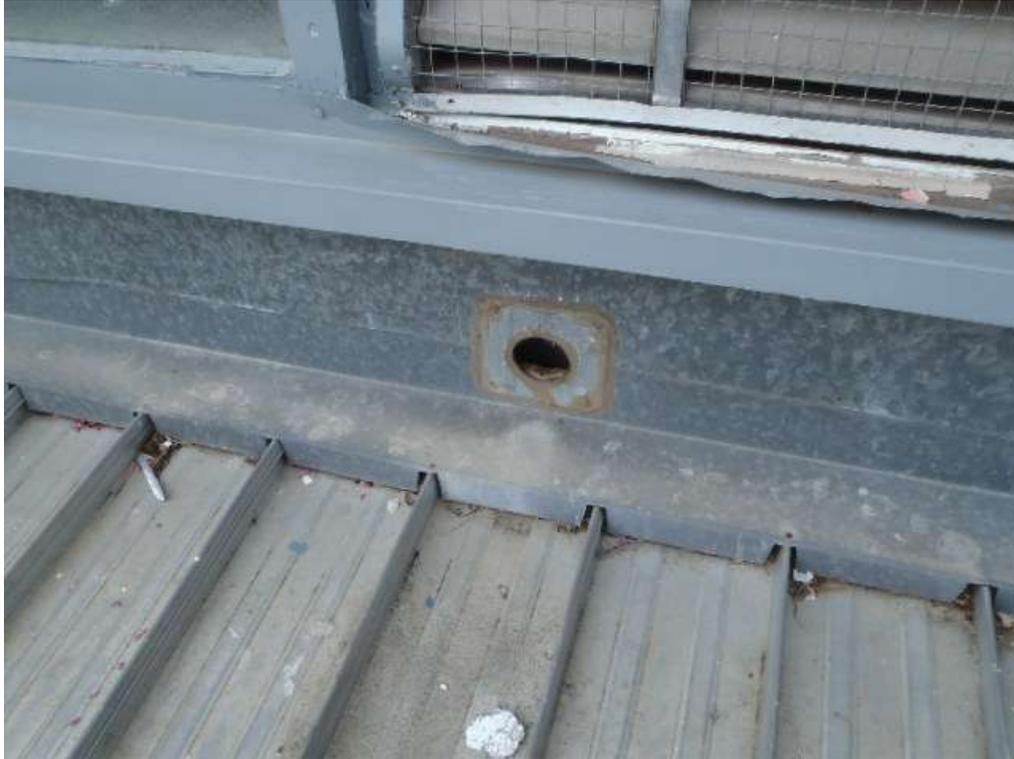
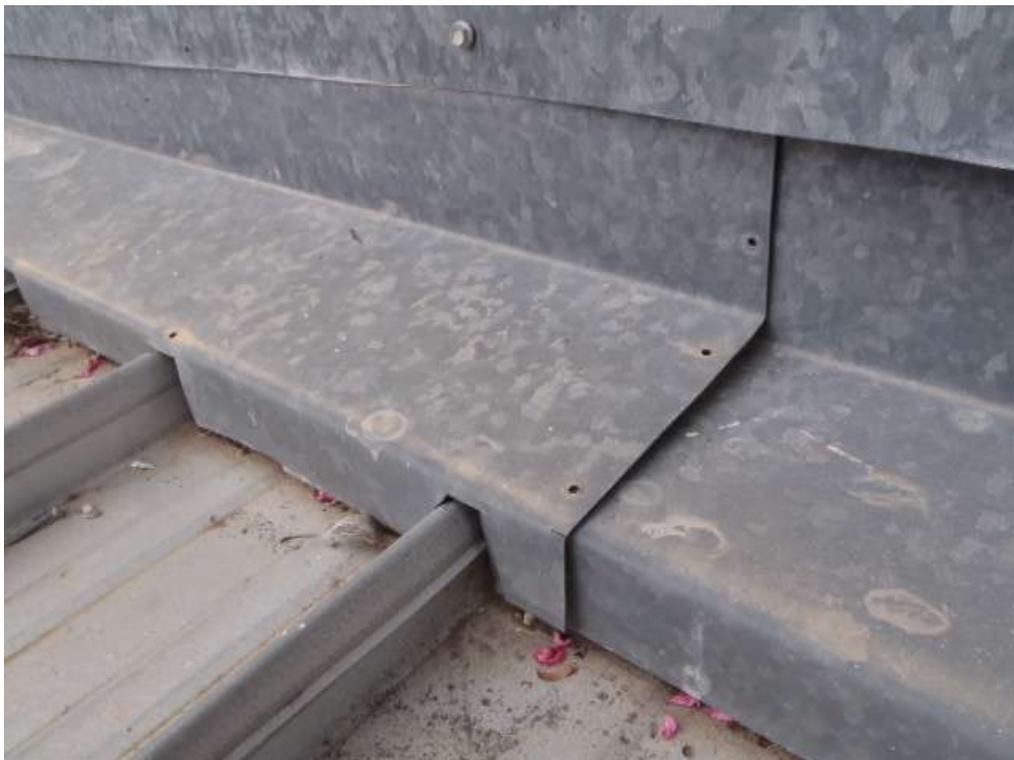
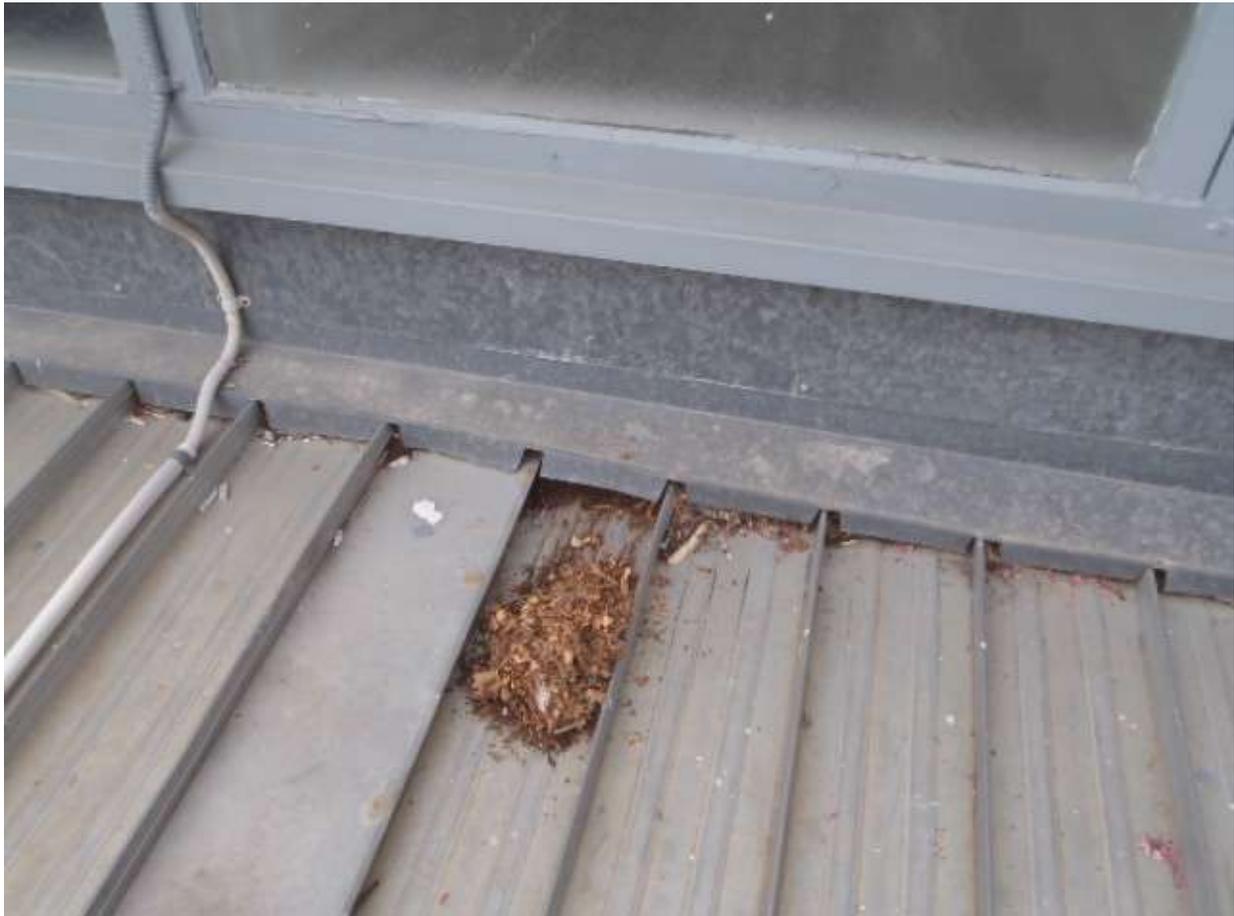
Area H

At area H there is a large hole in the up-stand of the galvanised apron flashing and in general the apron flashing is in poor condition (See photos below and on next page).

As you can see the turn-downs of the flashing are not overly tight to the trays of the deck roof because some of the fixings to the ribs have been missed or have sheared off. This allows debris to build up in the stop-ends of the roof sheets which can cause water ingress during heavy rainfall.

Replace the flashing with a wider one that is security fixed to the ribs with screws (not rivets). The best way to do the turn-downs is to make them 70mm and to fix the flashing so that the turn downs are sprung tight to the trays of the deck roof at 45°.

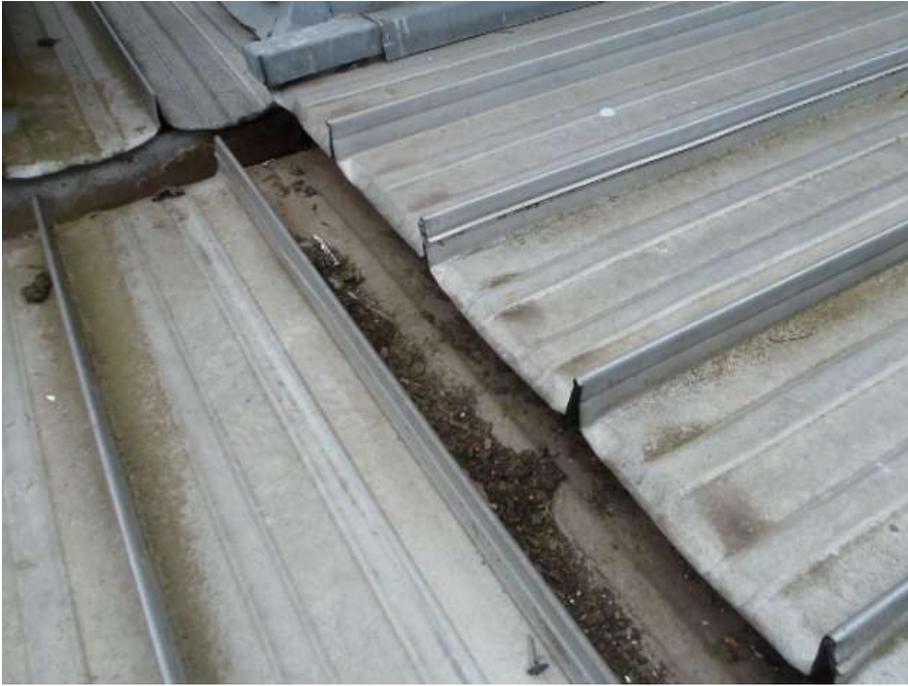
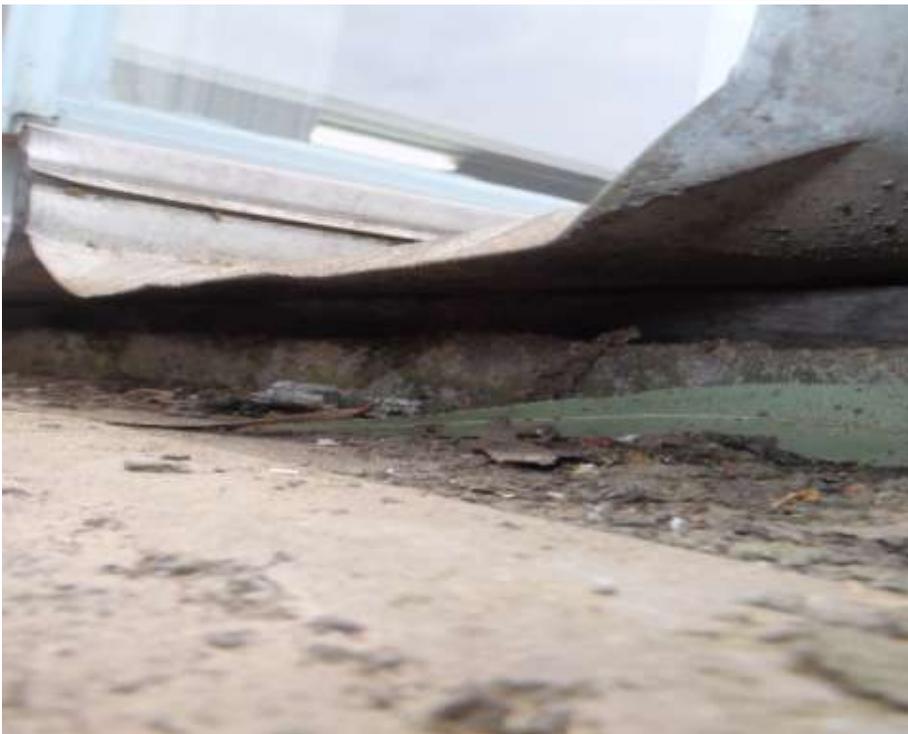
Area 'I'

At area 'I' the adjacent section of corridor roof once again discharges a large volume of water into the first roof tray (See below).

This entire area is poorly designed with regard to the volume of water it has to carry and as you can see in the above photo this is an obvious problem area.

Install an apron flashing that will carry the water from the corridor roof across and into the second roof tray. Make sure that the up-stand of the flashing is fitted tight up under the overhanging deck roof sheets.

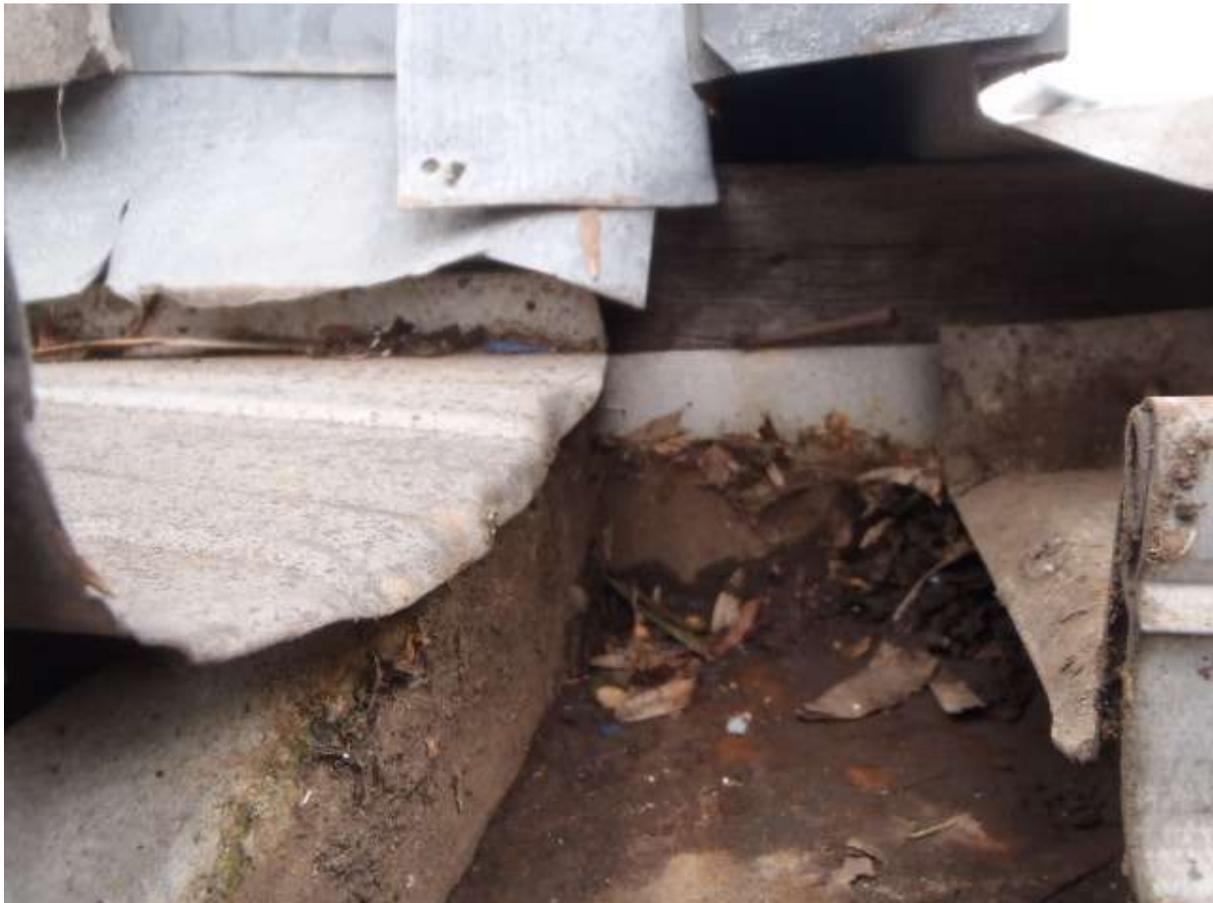
Area J

At area J the stop-end of the box gutter and flashings are very untidy and will be allowing water ingress in their current state (See below).

Replace all poorly installed flashings with new galvanised flashings making sure that no gap is left where water ingress can occur.

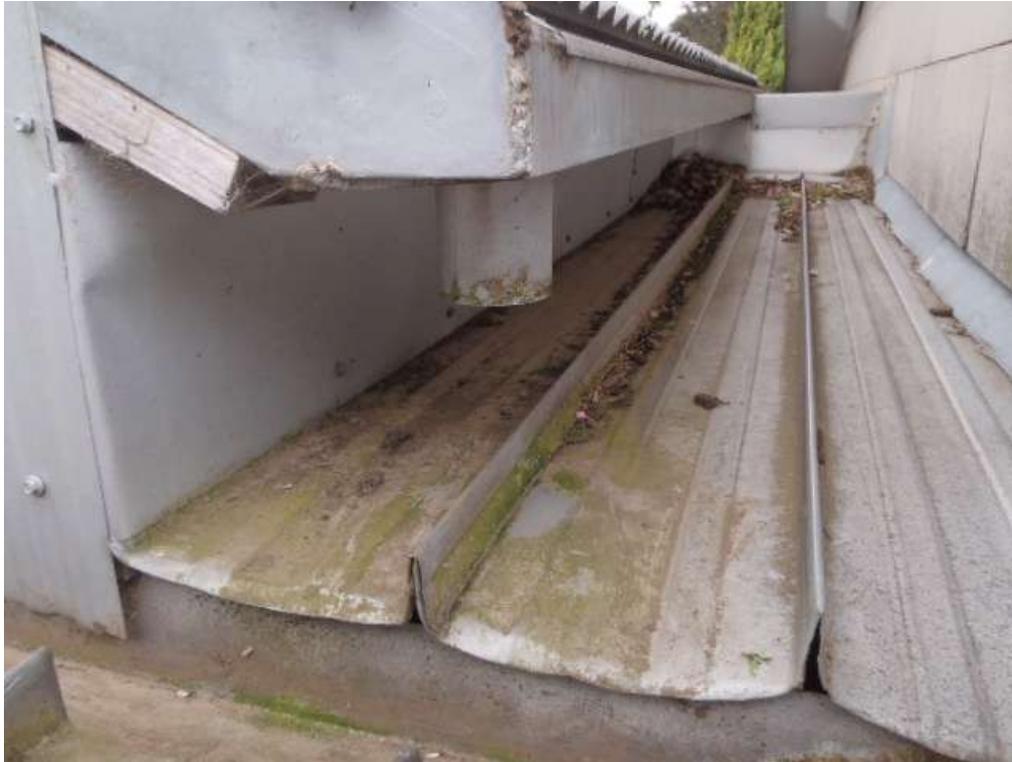
Area K

At area K there is another outlet from the upper roof discharging onto a problem area without a proper downpipe or spreader (See below).

Connect a 90mm diameter PVC pipe to the outlet and run the pipe around the face of the wall to discharge into the closest of the new rain-heads. If the volume of water discharging into the undersized box gutter can be reduced in any way it will minimise the risk of the gutter overflowing during heavy rainfall.
