To: Primary School

Property address: Corner of Maths Street and History Lane, Preston.
Victoria.

Date of inspection: 12 September 2014

The purpose of this report is used to identify the cause of water ingress through various areas of the new building and also the front entrance area.

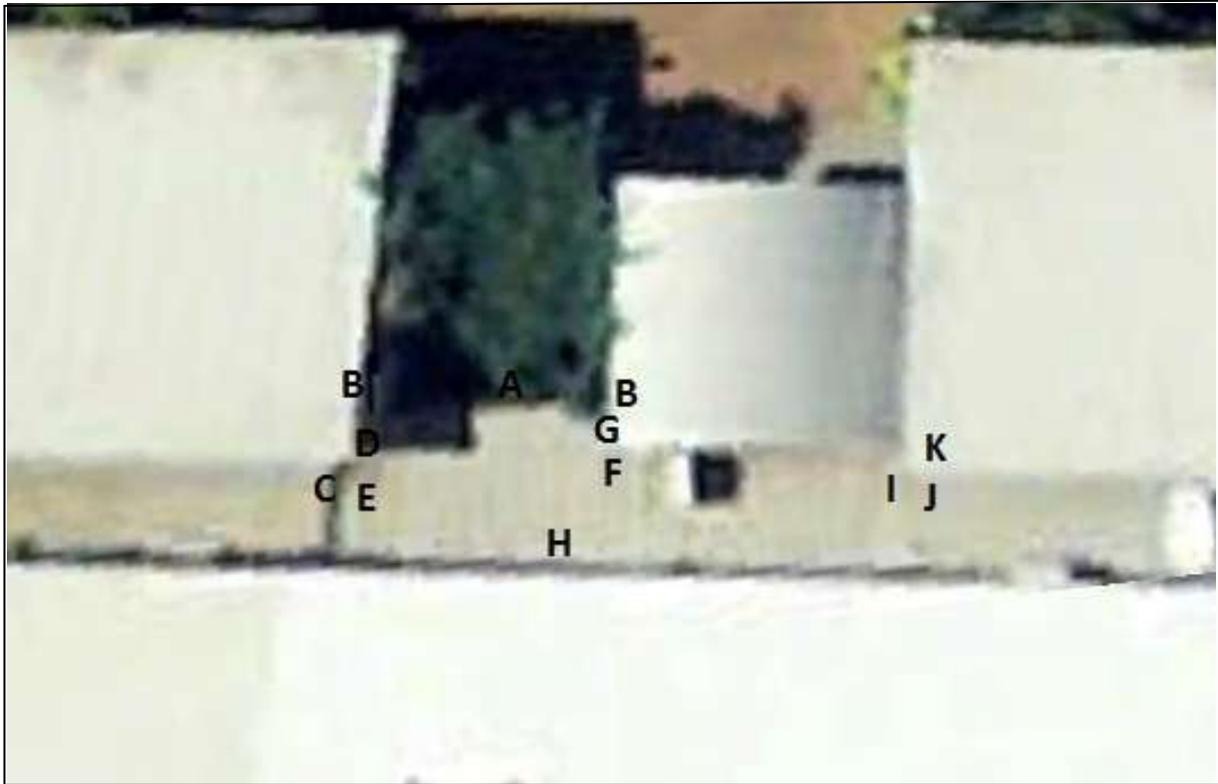
This section of the report is to be read in conjunction with the diagram below.

The area above the front entrance of the school is part of the older original roof and various sections have been added on over the years. Unfortunately not much thought has been given to the roof drainage system when these additional sections of roof were added.
